In re Flint Water Cases,
No. 16-cv-1044

Supplemental Report of Dr. Larry L. Russell

October 18, 2022

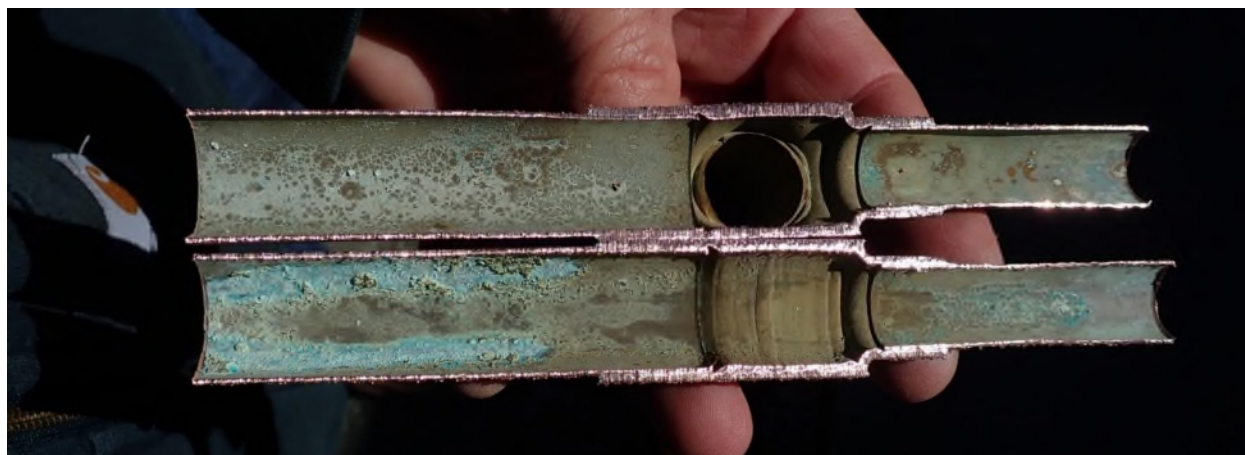
Figure 4.1-2: Pipe sample "A", sectioned.

The copper pipe also showed the existence of a phosphate scale likely deposited by the water treatment chemicals added to the water since the Flint Water Crisis occurred. Thus, it is likely that a substantial amount of this wall thickness was dissolved due to corrosion during the Flint Water Crisis, because this pipe was unprotected due to the absence of the orthophosphate addition. When the addition of orthophosphate was terminated in 2014 simultaneously with the distribution of the substantially more corrosive and high chloride level treated Flint River water distributed throughout the Flint water system, it is clear that conditions were ripe for the rapid corrosion of the copper pipes.

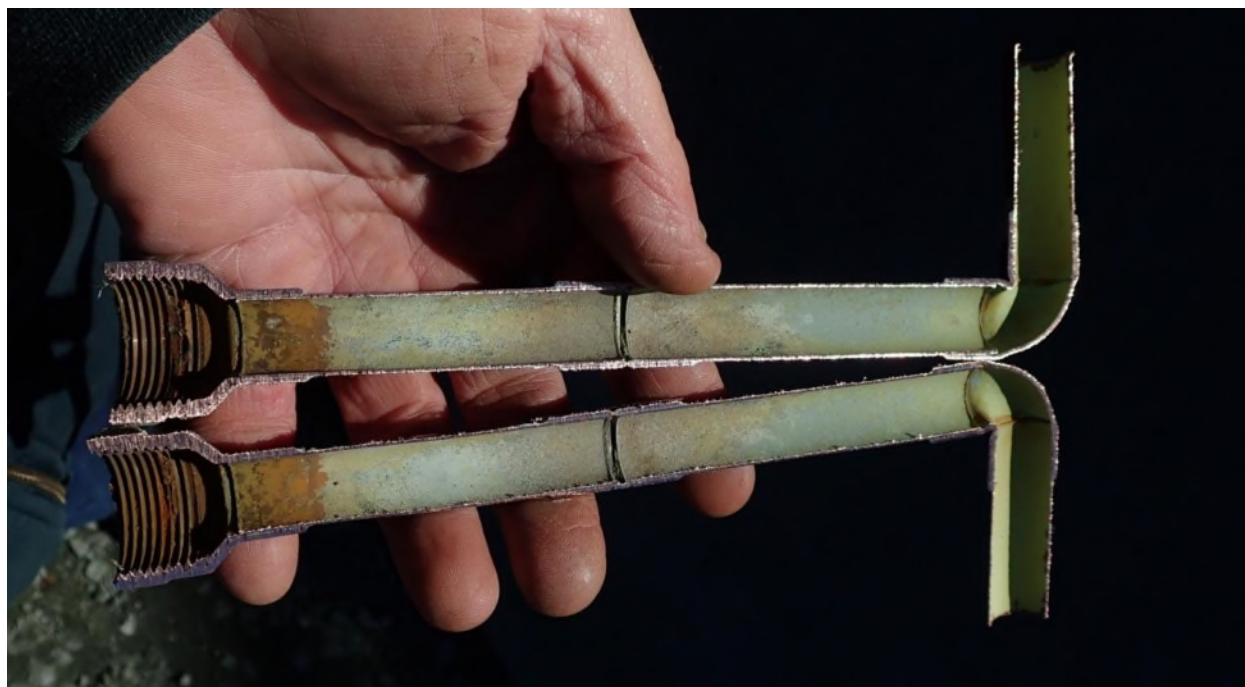
Figure 4.2-2: Pipe sample “E”, sectioned

The copper pipe also shows the existence of a phosphate scale deposited by the water treatment chemicals added to the water. Thus, it is likely that a substantial amount of this wall thickness was dissolved due to corrosion during the Flint Water Crisis, because this pipe is currently well protected due to the effectiveness of the orthophosphate addition in reducing copper corrosion. When the addition of orthophosphate was terminated in 2014 simultaneously with the distribution of the substantially more corrosive and high chloride level treated Flint River water distributed throughout the Flint water system, it is clear that conditions were ripe for the rapid corrosion of the copper pipes.
